## Columbia University – Baker Field

New York, New York

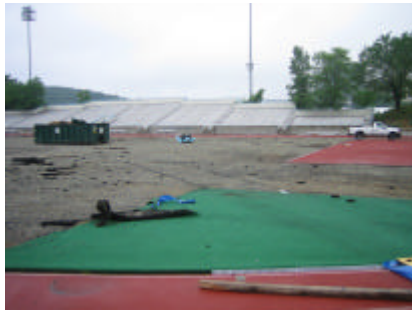
*Left top and bottom: Field replacement at Wien Stadium. Above center: Wien Stadium during a game. Below center: Inside the air supported tennis center. Right: One of the test pits made during the investigation of sinkholes in the football field.*

Opened in 1984, this 17,000-seat facility is home to Columbia's football, field hockey, lacrosse, and track and field teams. Following the installation of Astro Turf XL, Wien Stadium became a state-of-the-art facility. Most of the field is underlain by granular soils overlying coarse rock fill. These conditions are conducive to sinkhole formations when exposed to surface water infiltration. Placement of an impermeable liner was recommended to prevent surface water infiltration. An underdrain system below the turf provides filed drainage and minimizes surface water infiltration.
