Metro North's Croton Point Avenue Bridge Replacement

Croton-on-Hudson, New York

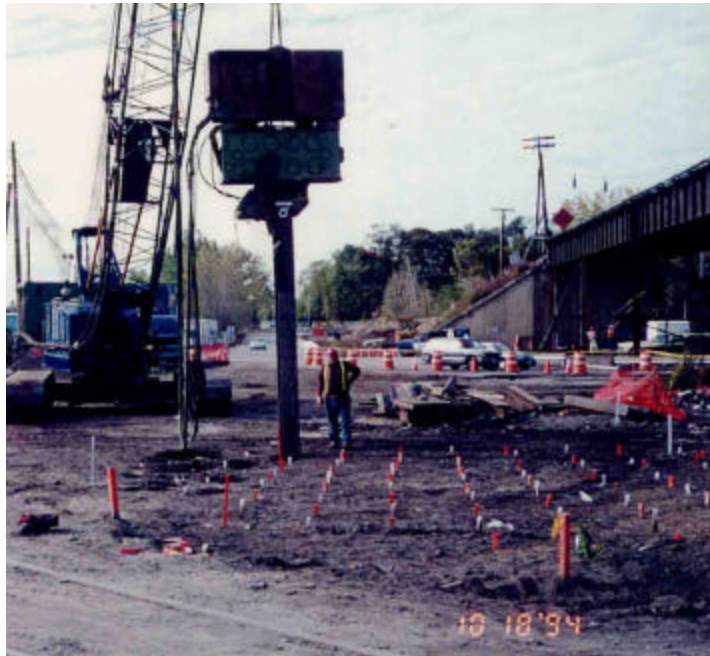
Both photos taken at Pier P2, with a view to the west. At left: Vibratory probe grid prior to the start of the densification. Note the close proximity to existing bridge. At right: Densification of the subgrade using vibratory probes.

MRCE designed the spread foundations for the bridge piers and prepared contract documents for the earthwork, soil densification and monitoring of adjacent structures. Soil densification procedures specified included vibratory probe test sections with monitoring of ground surface subsidence and cone penetration testing to aid in optimizing the probe spacing.

During construction, MRCE provided a geotechnical engineer to oversee the densification test section work. MRCE evaluated the results of the test sections and selected the final probe spacing. MRCE made periodic site visits during production densification and reviewed the settlement data for each pier. As the work progressed, MRCE modified probe spacing as local utilities were exposed to avoid intolerable settlement.
