## **St. Felix Street Settlement**

*Brooklyn, NY*

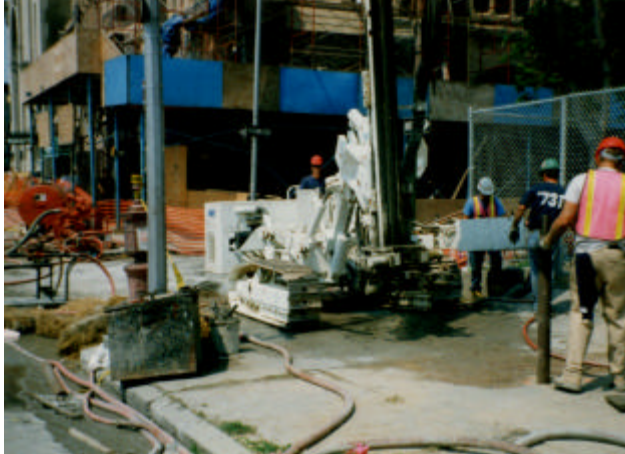
*Deep soil grouting (above) during Phase I and placing the geogrid (at left) during Phase II of the reconstruction of St. Felix Street.*

A combination alternative of shallow soil stabilization with geogrid reinforced fill and deep soil grouting to fill voids was recommended to NYCDOT for the reconstruction of St. Felix Street. NYCDOT gave approval to proceed with design and preparation of contract documents for the reconstruction of St. Felix Street between Hanson Place and Lafayette Avenue. A phased approach was proposed for the work. Phase I would accomplish the deep soil grouting. Phase II would complete the reconstruction with shallow soil stabilization with geogrid reinforced fill.
