Joel and Joan Smilow Research Center at NYU Medical Center

New York, NY

Foundation Engineering Project Highlights

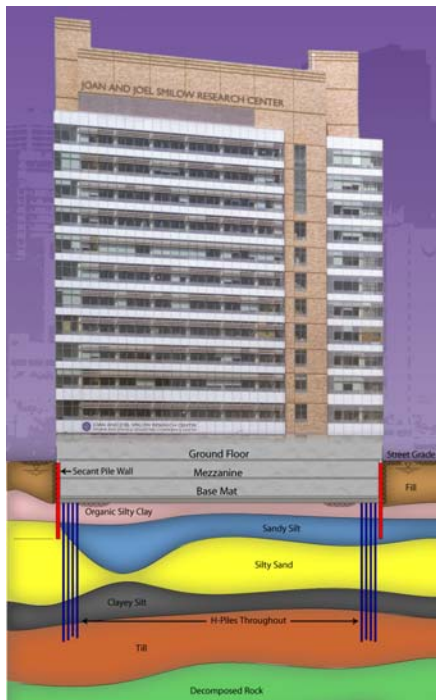
Above: Completed building with soils showing complicated underground. MRCE has performed over 50 projects for NYU Medical Center over the years. The new Smilow Research building is one of the most recent. At right: Excavation of basement for this constrained site. Note adjacent buildings on left and FDR Drive on right.

This new biomedical research center faces the East River next to FDR Drive and is part of the NYU School of Medicine and the other buildings that comprise the NYU Medical Center Complex in Manhattan. It was constructed on a site that included a courtyard surrounded by several existing buildings and where soil conditions are poor, and the groundwater table is high due to the close proximity of the East River. As foundation engineers on the project, Mueser Rutledge Consulting Engineers (MRCE) came up with an innovative solution for construction of the foundation that allowed the installation of a fairly watertight excavation shoring system with enough rigidity to limit movement of adjacent buildings, and that could be installed in a limited work space available at the site. MRCE's innovative solution involved a secant pile wall—a line of individually drilled and concreted of piles that overlap one another to form a continuous watertight wall. The secant wall provided temporary excavation support and later it becomes the permanent foundation wall for the building. After the wall was constructed, basement space was excavated. Adjacent buildings were monitored for movement throughout the construction process. The secant pile wall was sealed by injecting a chemical grout into joints that showed dampness, and then the entire wall was waterproofed using a specialty waterproofing system applied on the inside face of the wall.
