## **World Trade Center Recovery Effort**

*New York, NY*

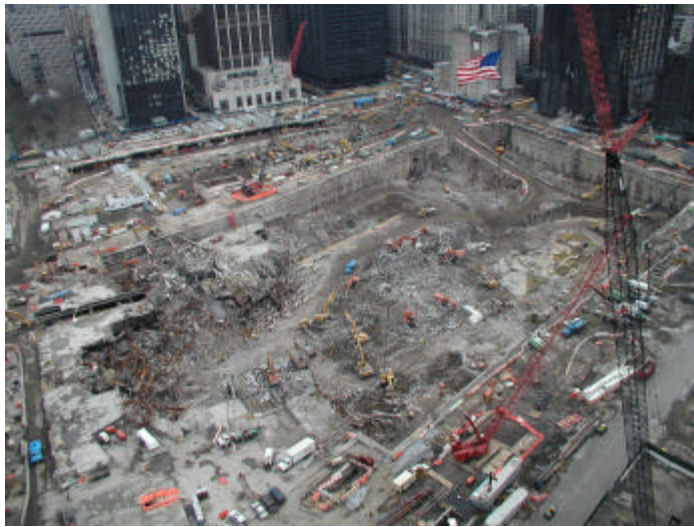
*Above: Site overview taken 2/4/02 during tieback reinstallation. At right: MRCE engineers conduct load tests on tiebacks. At left: MRCE engineers performed a condition survey of the damage on the 1/9 and N/R subway lines under and near the WTC site following the collapse of the towers.*

- MRCE engineers conducted damage assessment within the slurry wall perimeter. Of particular concern is the support of the slurry wall. Following damage assessment, MRCE developed a scheme to support the slurry wall while the rubble is removed and tiebacks are reinstalled. Slope indicators and monitoring wells are installed at strategic locations along the slurry wall to monitor water levels and wall movement during rubble removal.
